Plant Response to 14 Engineered Log Jams on the North Fork Toutle River, WA Sediment Plain

Plant Response to 14 Engineered Log Jams
on the North Fork Toutle River, WA Sediment Plain

Master of Environmental Management

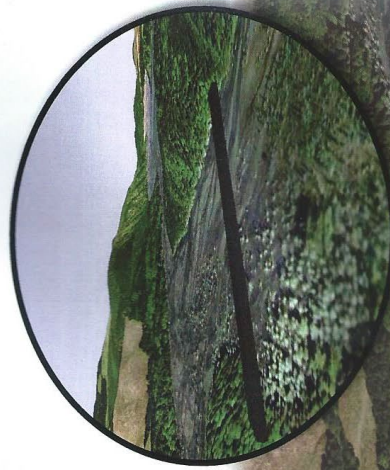
The diversion berm will direct the majority of flow over the structures in the test area for the duration of the monitoring period.

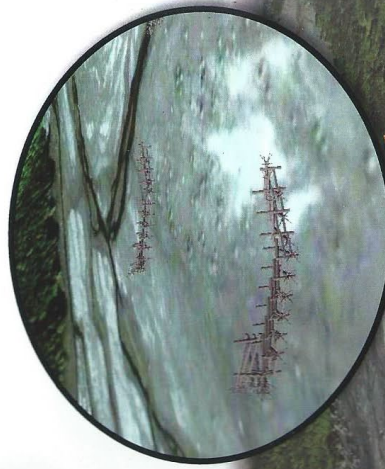
A series of "engineered log jams" will produce an eddying effect as water flows around them, causing sediment to drop out in the slower water, creating islands behind each log jam.

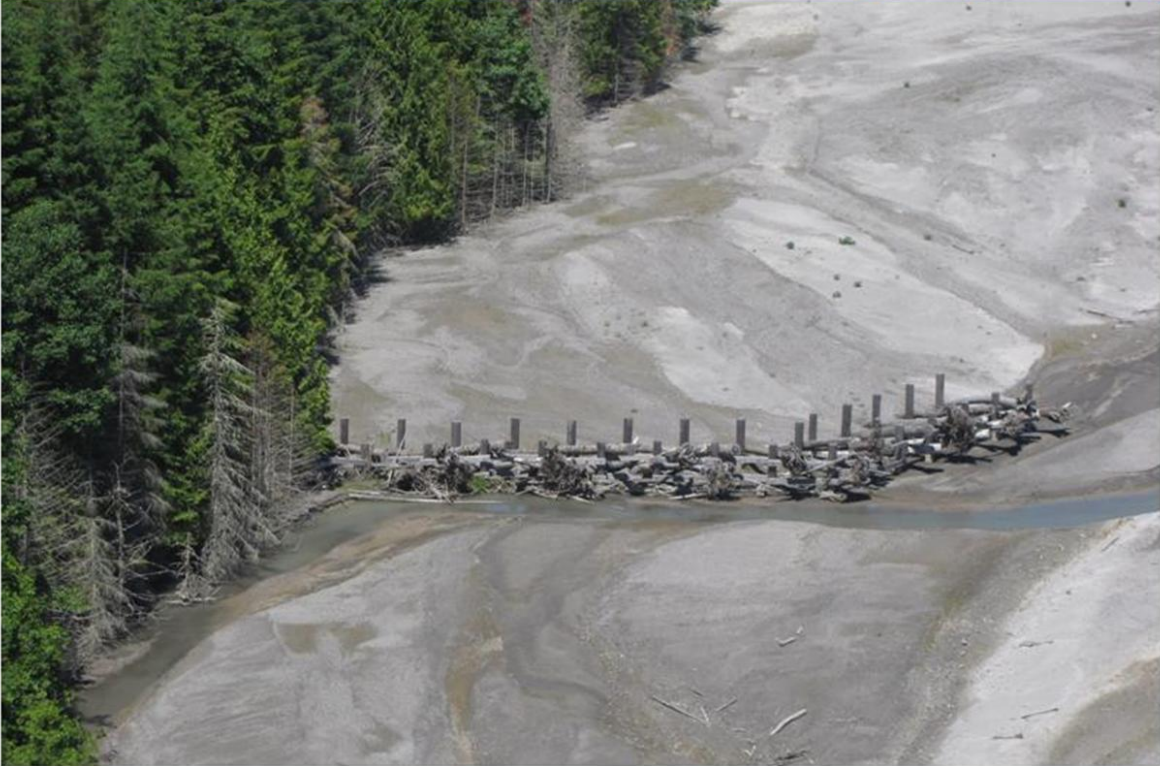
Structure	Condition	Functionality	Recommendation
StrAw	Unsatisfactory	Partial	Urgent - Repair

StrAw is in surprisingly good condition considering that it took the full force of the NFTR once the river was returned to a course to the North of the big island, in October 2010. Practically all the racking is gone, though some drift wood has lodged against the piles and some vegetation has started to grow. The sediment surface behind the structure is noticeably higher than that in the channel that flows around the right wing. This is likely due to the effect of the cross-valley structure downstream, which deflects the NFTR to the right and away from StrAw. It is also apparent that the small sub-channel of the NFTR that currently encounters the structure has probably incised by 1 or 2 feet since 2010. In any case, the elevation difference between the attached bar (island?) downstream of StrAw and the adjacent channel may be partially attributed to the past functioning of the structure. It is, however, unclear whether it would continue to function as intended should the main channel of the NFTR return to attack it again, though this does not seem an imminent prospect as the NFTR is current over at the right side of the sediment plain, interacting with the Type A structures. Nevertheless, urgent repairs are needed as the NFTR could change course again at any time.

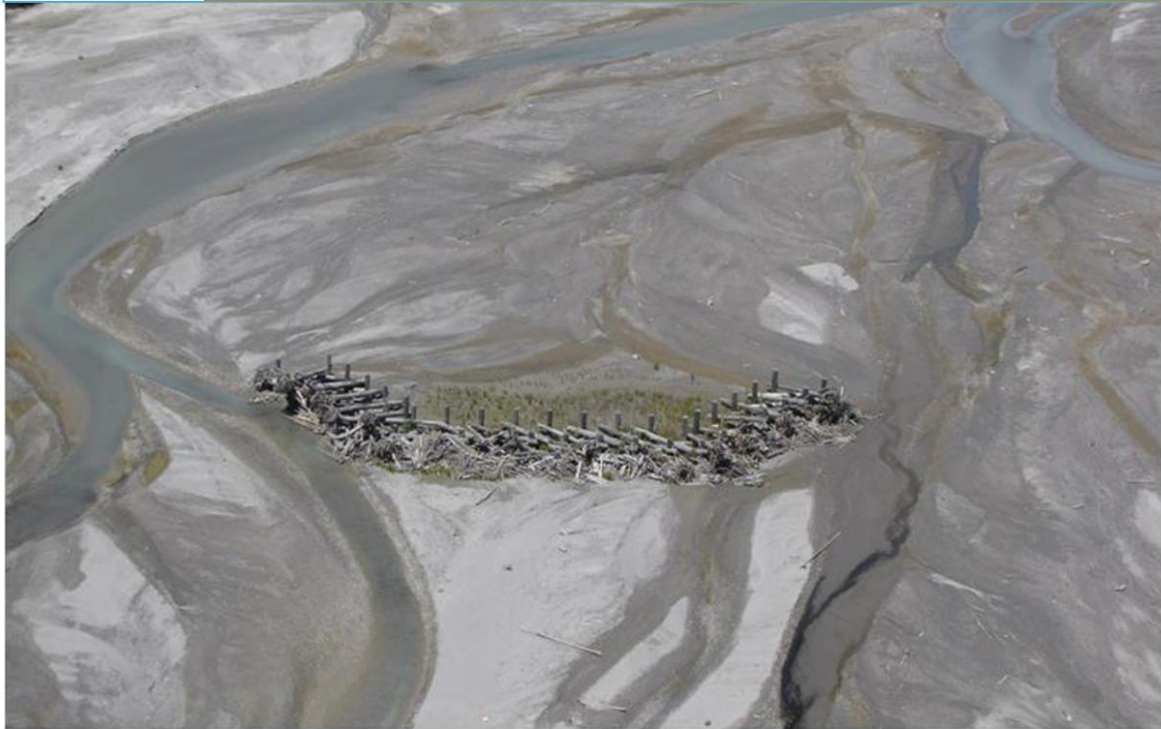
Brian is structurally sound although it does not appear to have been built with a berm. There was heavy attack by the mainstream NFTR in 2011, with flow through the left wing removing racking and cutting across the island from left to right at an obtuse angle (similar to what is currently happening at Walsh), The island was dissected and seriously eroded in 2011, though the cross-island channel was filled-in by deposition in 2012, as the NFTR mainstream migrated to the north and east. Nevertheless, this reworking of the island has made its current vegetated area very small and triangular. The structure was heavily attacked by the mainstream NFTR in 2011, so it is doing surprisingly well in light of that. However, racking is missing entirely from the left wing and vegetation (grass) is limited in extent, sparse in density and of low diversity.

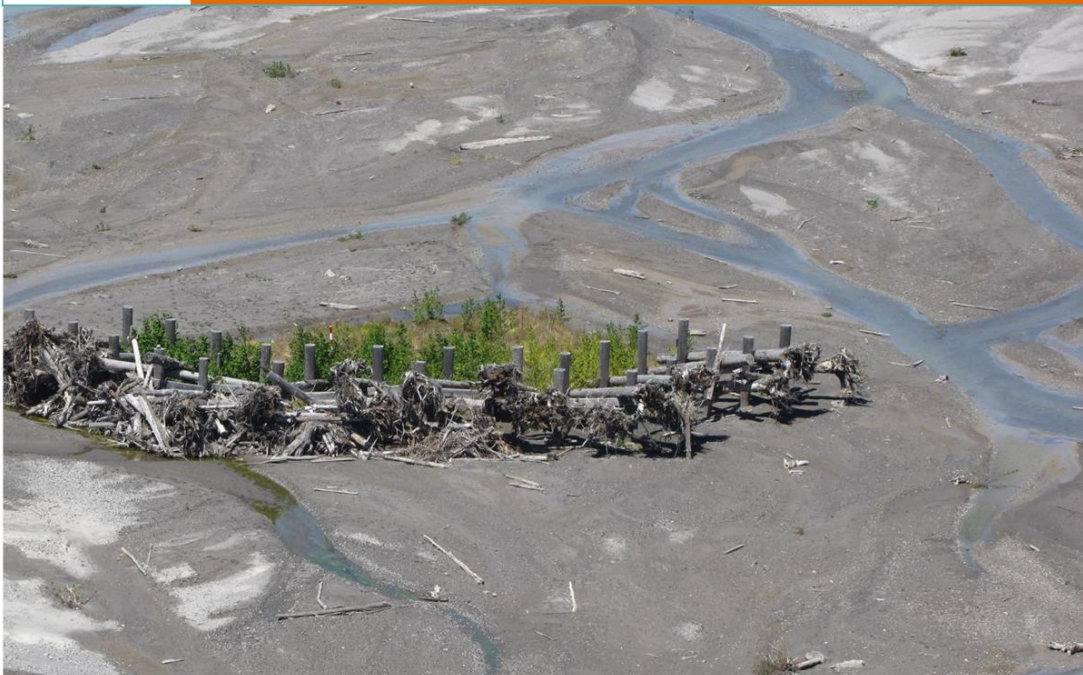
Dwayne is in good condition structurally considering that channels were scoured on both flanks of **Dwayne** in 2011 by anabranches of the mainstream NFTR (see Figure 3.33). However, the right wing and the right third of the center section lost all their racking such was the ferocity of the fluvial attack in 2011. The island has a well vegetated, diamond shaped center, although the marker post indicates that there has been no net accretion of sediment behind the structure since its construction. There was accretion around **Dwayne** in 201 and it is not currently experiencing intensive flow attack from the NFTR, but it would be highly vulnerable should the river sweep back to the south or avulse onto a new course that renewed scour around the structure. In this eventuality, **Dwayne** would be partially functional at best, allowing erosion and reworking of its island and functioning only about as well the two Type-B structures immediately upstream (**Kim** and **Jim**), are functioning at present.

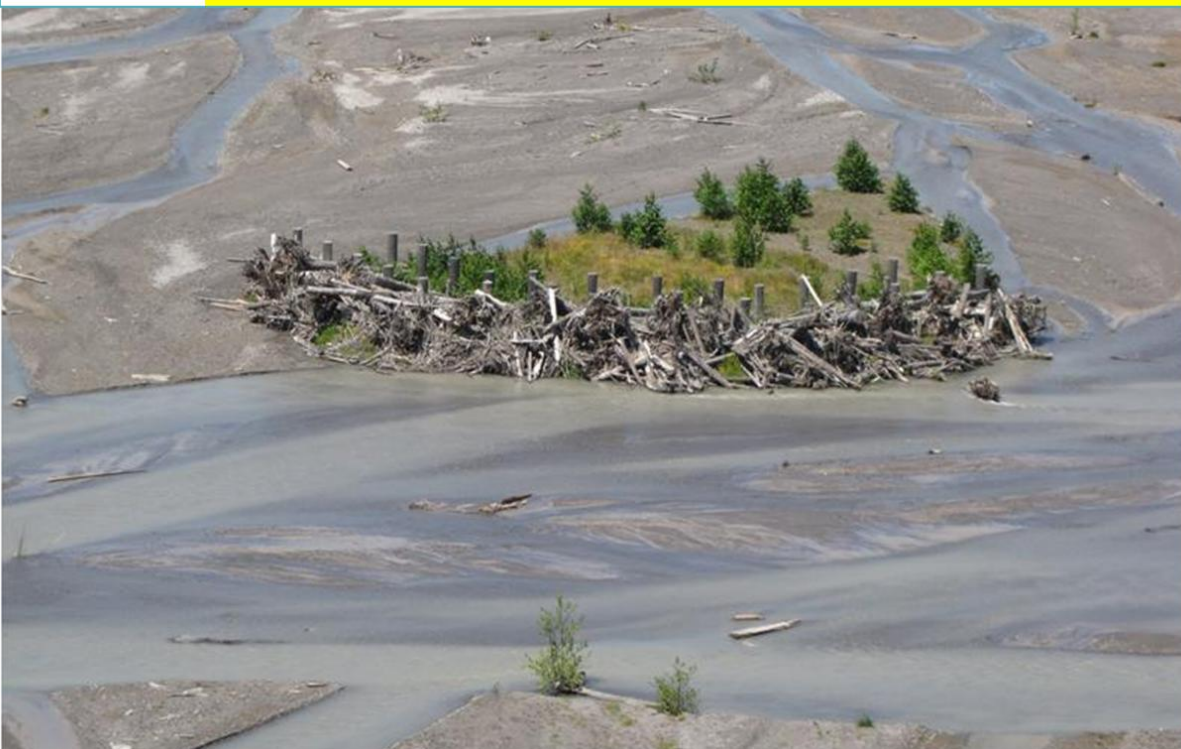
Eagar is in good to excellent condition and is functioning as intended. In 2011 and 2012, Eagar deflected scouring anabranches of the NFTR to either side of the structure, but currently, Eagar is deflecting the main channel of the NFTR across the upstream face of the structure, to the right. This is protecting the island although it is directing the flow on to the left wing of the next structure to the right (Office) and that oblique attack has caused extensive damage to Office. Structurally, Eagar is 'as built' and its racking is still present, although it is dry, shrunken and therefore not as effective in deflecting flow and protecting the island downstream of the structure as it would have been when first installed. The island is extensive and clearly defined – in this respect, Eagar's island currently sets the performance standard for an island-forming structure. Vegetation in it indicates that part of the vegetated island that had developed in the past has been re-worked, though it is unclear when. The re-worked area is now again re-vegetating, demonstrating the resilience of the island when the racking stays in place and the structure performs as intended.

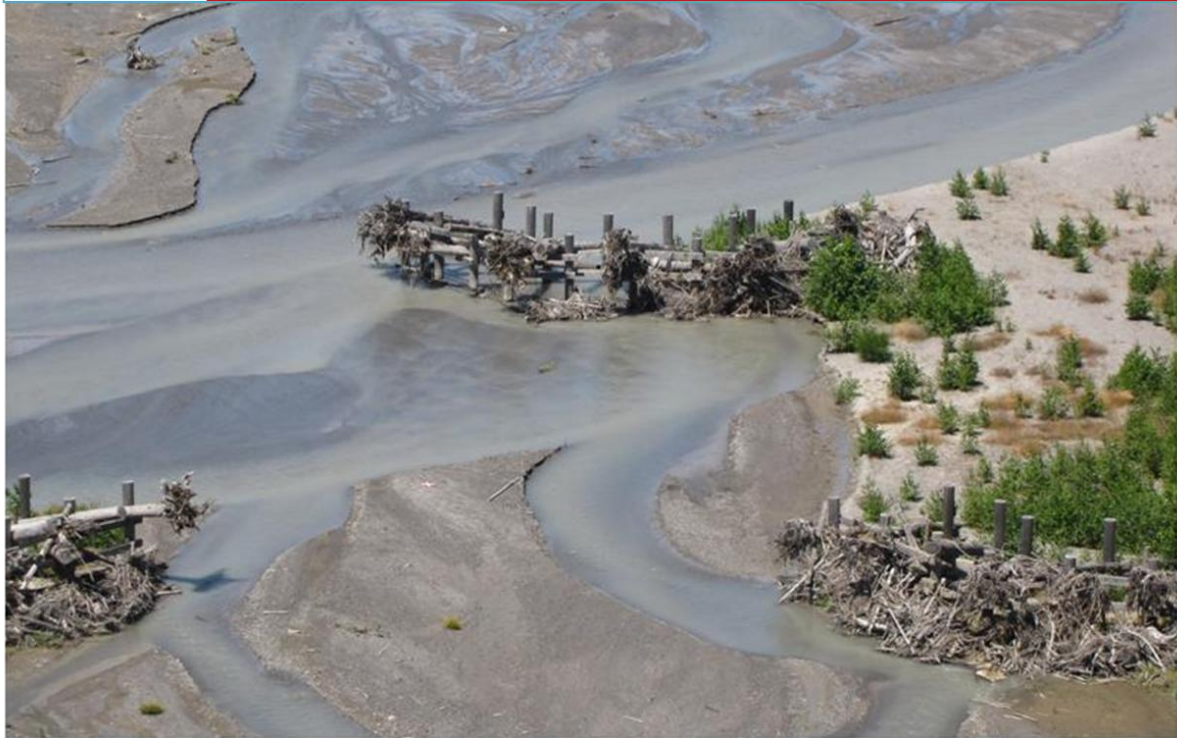
The left wing of OfFice was first attacked by an anabranch of the NFTR in 2012, but it deflected flow successfully to the left (see Figure 3.33). It was still fully functional when inspected on June 5th 2013, but by late-July strong fluvial attack by the main channel of the NFTR had seriously damaged it by scouring the bed, berm and removing racking throughout the left wing and over half the centre of the structure. This occurred due to high, snowmelt flow that was deflected by Eagar to approach OfFice at an oblique angle. Flow attack then shifted laterally in a growing curve downstream of OfFice to re-erode sediment that had been deposited behind the structure and cut an embayment 50 m deep into the proto-floodplain on the right (north) margin of the sediment plain, where there was on June 5th a young but dense stand of alders. Hence, despite limiting the NFTR from migrating even further into the proto-floodplain and shielding the next structure in the second row (Gurney) in 2013, OfFice must now be classified as dysfunctional. Currently, only the right 1/3rd of the center and the right wing of OfFice still have any of their original racking and berm intact, and both will be lost as scour within the structure continues. Consequently, loss of sediment and vegetation behind the structure are likely to continue unless the OfFice is repaired and strengthened before next year's rainstorm and snowmelt floods; making repair time critical.

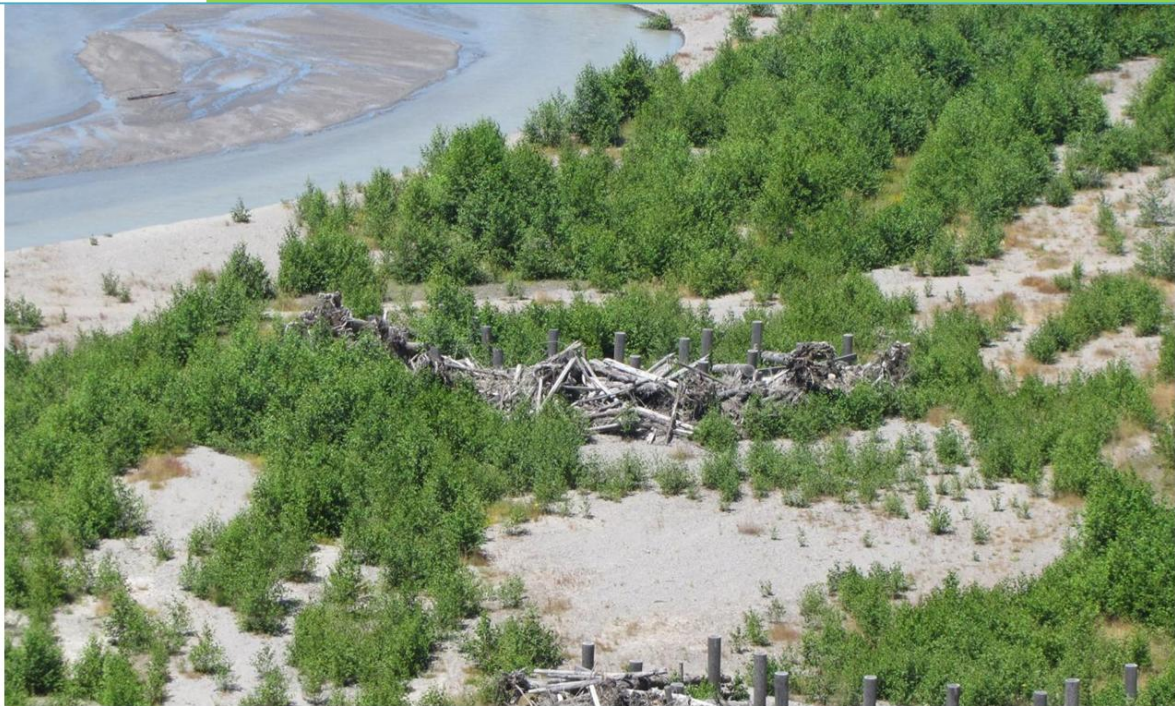
Gurney is almost (perhaps completely) undamaged by the NFTR and is essentially 'As Built' except that its racking has dried out and shrunk in height and volume. This is the case because the NFTR has not flowed through the area around the structure since 2009 and the structure and its zone of influence is currently contained entirely within the right margin proto-floodplain in the sediment plain. Alders dominate the dense vegetation not only behind but all around the structure. There is a small, abandoned channel between **Gurney** and **Office**, which did generate some scour close to the left wing in 2011. To the right, a corridor of sparse vegetation exists, up to a dense alder hedge that separates that corridor from the next back channel – which does have water in it. This pattern of channels separated by dense hedges of alders continues to the wall-base channel between the edge of the sediment plain and the north valley side.

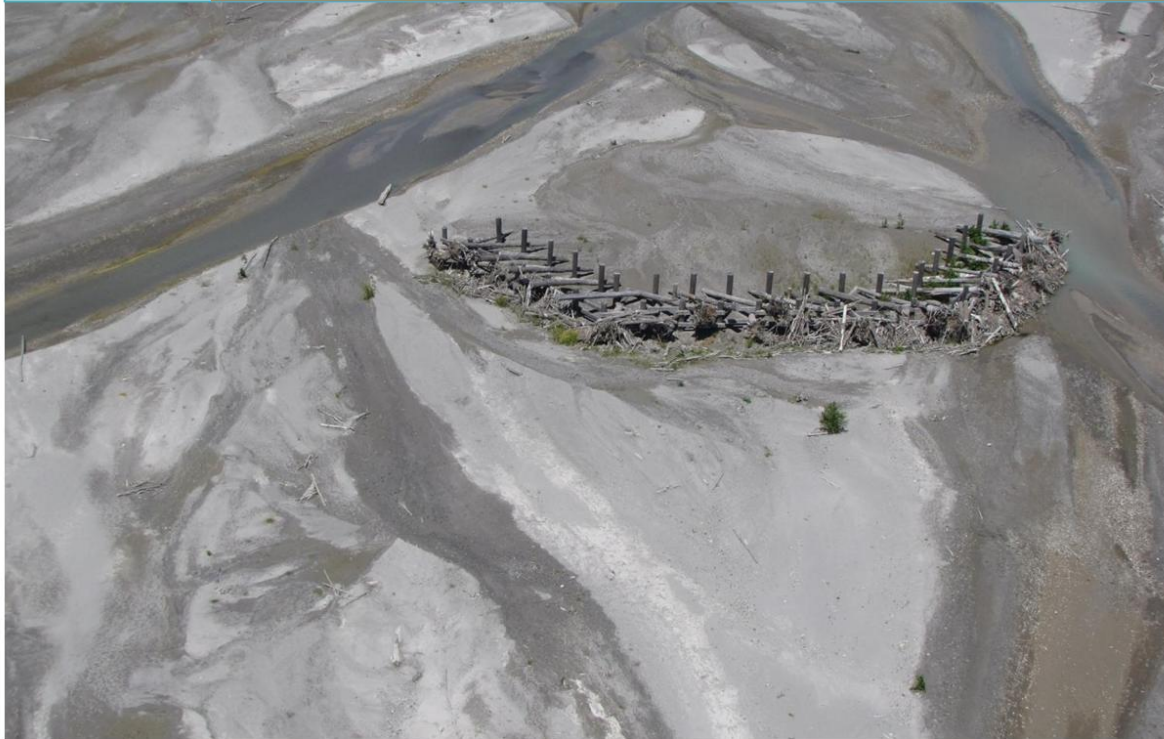
JoHn was subjected to heavy attack by the NFTR mainstream in both 2011 and 2012, but has come through relatively well. Racking is damaged on the left wing, missing almost entirely in the centre but is more or less intact on the right wing. The island behind the structure has been reworked by flow passing through the structure at some time and vegetation (riparian species) is sparse and young as a result. Willows are doing OK in the right wing, which has been protected by the intact racking. Structurally, John has not been damaged even by attack by the full force of the NFTR for 2 years, and the structure should

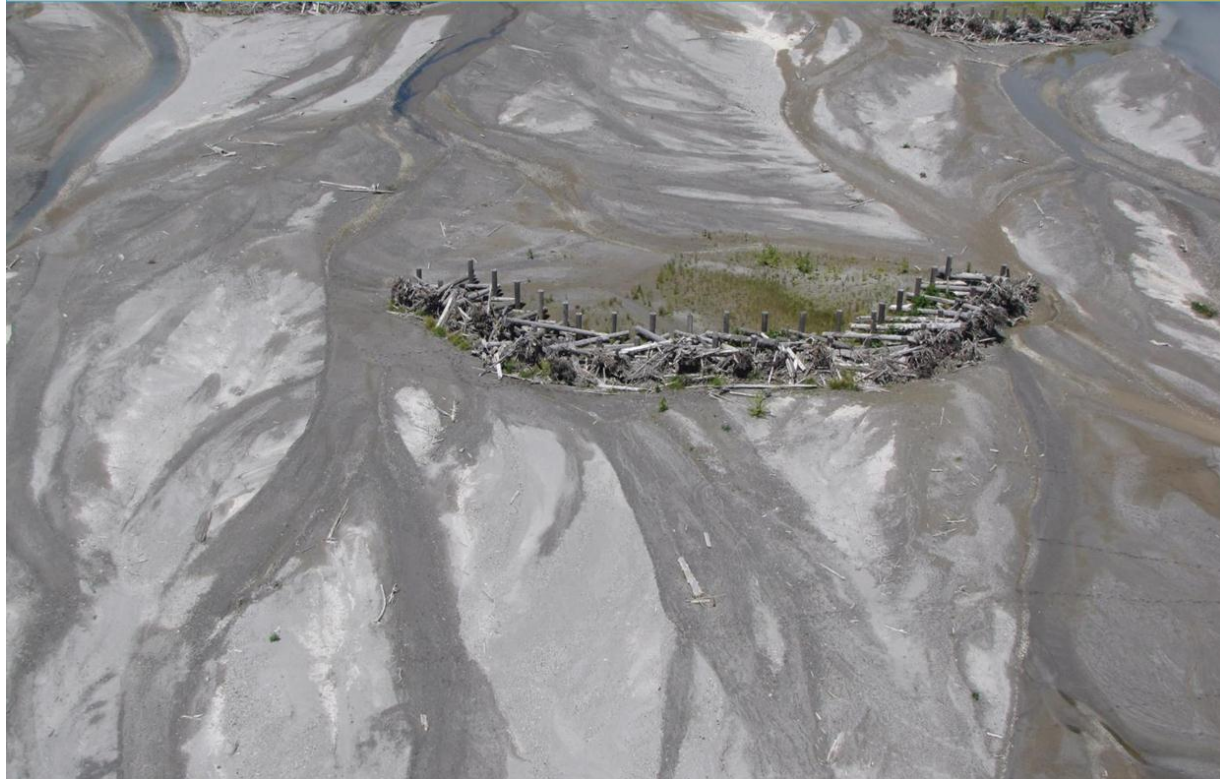
SI was not attacked as heavily as John in 2011, though it did interact with anabranches of the NFTR mainstream in 2012. It is structurally sound and it has most of its racking in place as a result. That said, it appears that flow has come through the center and left wing, probably between 2011 and 2012, as the NFTR migrated northwards. The berm in these parts of the structure has been eroded and there are signs of reworking (i.e. erosion and re-deposition) and removal and re-growth of vegetation. The island is vegetated by riparian species but its area is truncated on the left side by a currently abandoned sub-channel of the NFTR that once flowed across the back of SI from left to right – similar to the channel currently attacking Walsh. SI's condition assessment demonstrates that while flow through or across the back of a structure re-erodes accumulated sediment and vegetation from the island, the island recovers subsequently when the channel passing through the structure migrates away or is abandoned. Nevertheless, if attacked again by a large sub-channel of the NFTR, SI would provide limited protection to its island and would, therefore, function partially at best. As such flow attack could be renewed at any time, urgent repairs to the racking and berm are necessary.

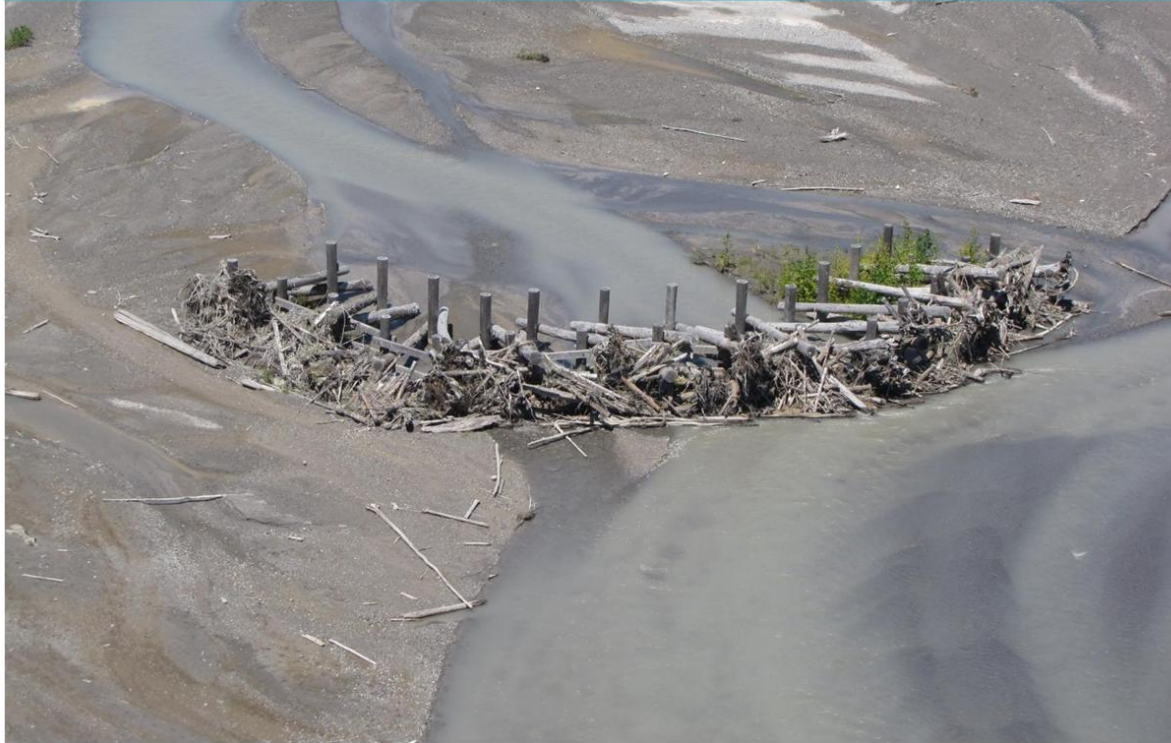
Jim was attacked by a substantial anabranch of the NFTR in 2011, mainly on its left wing, and by a branch of the mainstream in 2012. The structure is unusual in that the racking is in fairly good condition, but is currently ineffective in deflecting all of the flow in the approaching main channel of the NFTR as it strikes the centre of the structure. Most of the flow is successfully deflected to the right, but a portion goes straight on under and through the centre of Jim. This is because deep scour and high approach velocities in the NFTR mainstream have scour below the racking and water is passing underneath it. This flow has

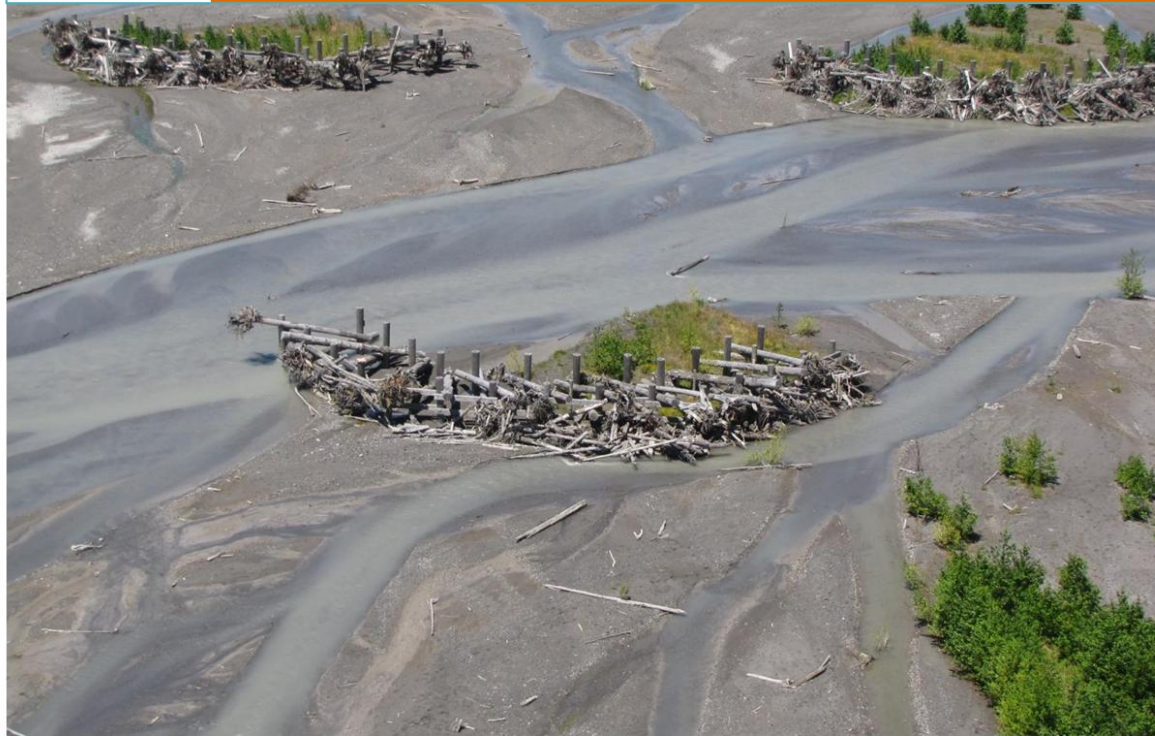
Kim's left wing was persistently attacked by a large anabranch of the NFTR in 2011, which scoured a deep channel close to and partially within the left wing of the structure. That channel migrated into the left wing in 2012. In 2013 the mainstream NFTR approached the study area along an axis between **Jim** and **Kim**, with most of the flow being deflected laterally to the right by **Jim**, to attack **Kim's** left wing at an oblique angle. A second, smaller anabranch attacked the right wing at the same time. Despite experiencing persistent fluvial attack, **Kim** is still functioning at perhaps 60% of full efficiency, but it has lost all racking

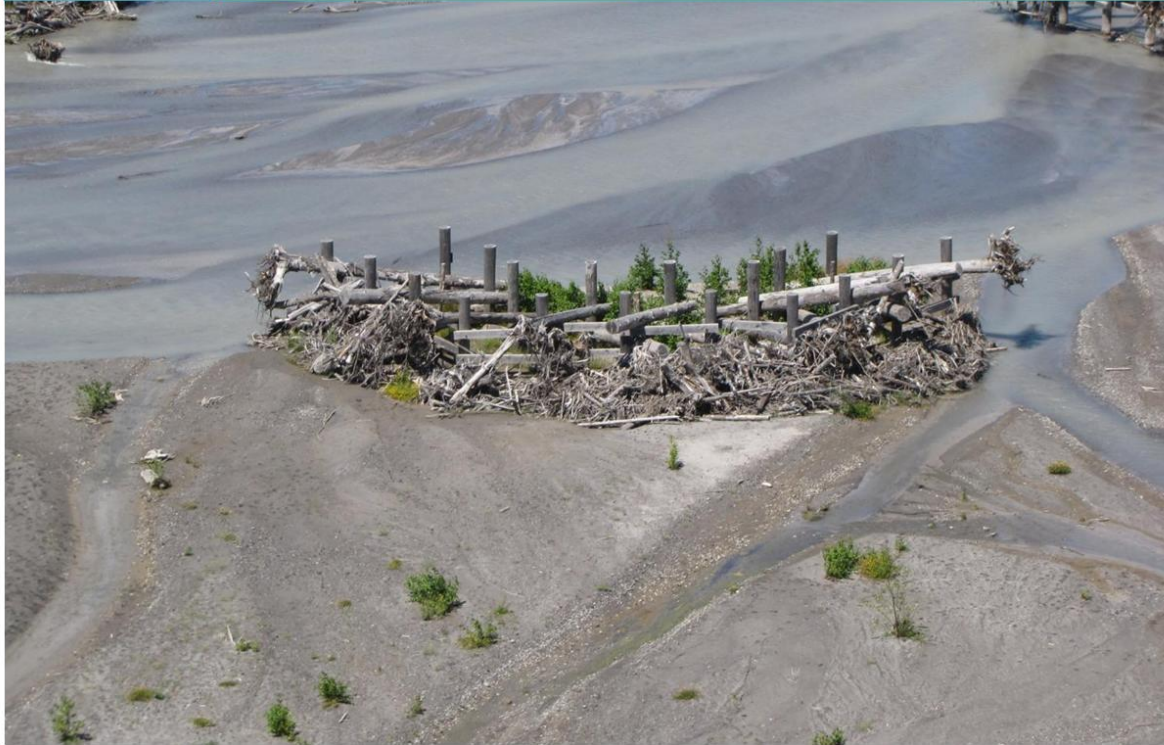
WaLsh performed really well between 2010 and 2012, when it was subjected to serious frontal attack by secondary, but aggressive anabranches of the NFTR, building a well-defined and vegetated island in the process (see Figure 3.34). However, in 2013 one of the anabranches of the mainstream NFTR deflected to the right by Jim has been flowing laterally across the back of WaLsh and this has completely removed the sediment and vegetation that had accumulated and grown in its island, re-eroding all the way back to the rear edge of the berm. The vegetated island that had developed between 2010 and 2012 has been almost

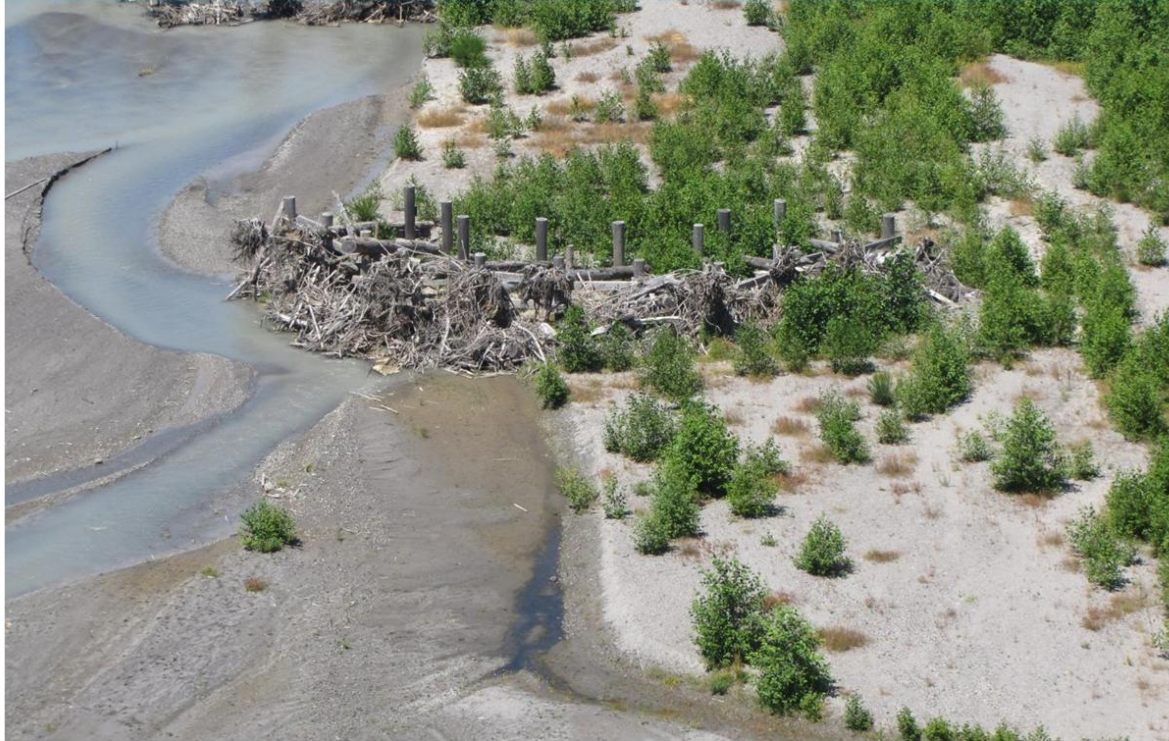
Mike has been attacked by a secondary anabranch of the NFTR/Hoffstadt Creek almost continuously since 2010. While this anabranch has scoured a deep channel in front of and to the right of the structure, **Mike** remains structurally sound and continues to be effective in protecting from lateral erosion the proto-floodplain on the right margin of the sediment plain. Also, **Mike** provides important protection to **OffFice** (which is in the second row, behind **Mike** and to its left). In fact, together, **Mike** and **OffFice** are currently the two most important structures in providing effective scour control to the sediment body and young

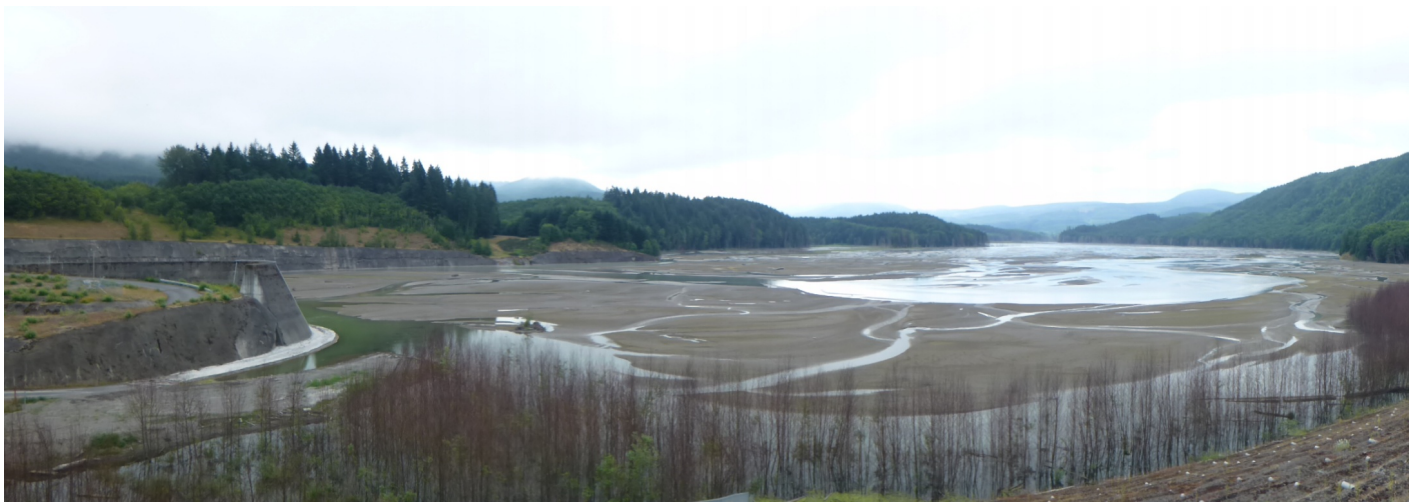
July 2013: Sedimentation upstream of the SRS in response to the 2012 spillway raise (photograph taken by lead author)

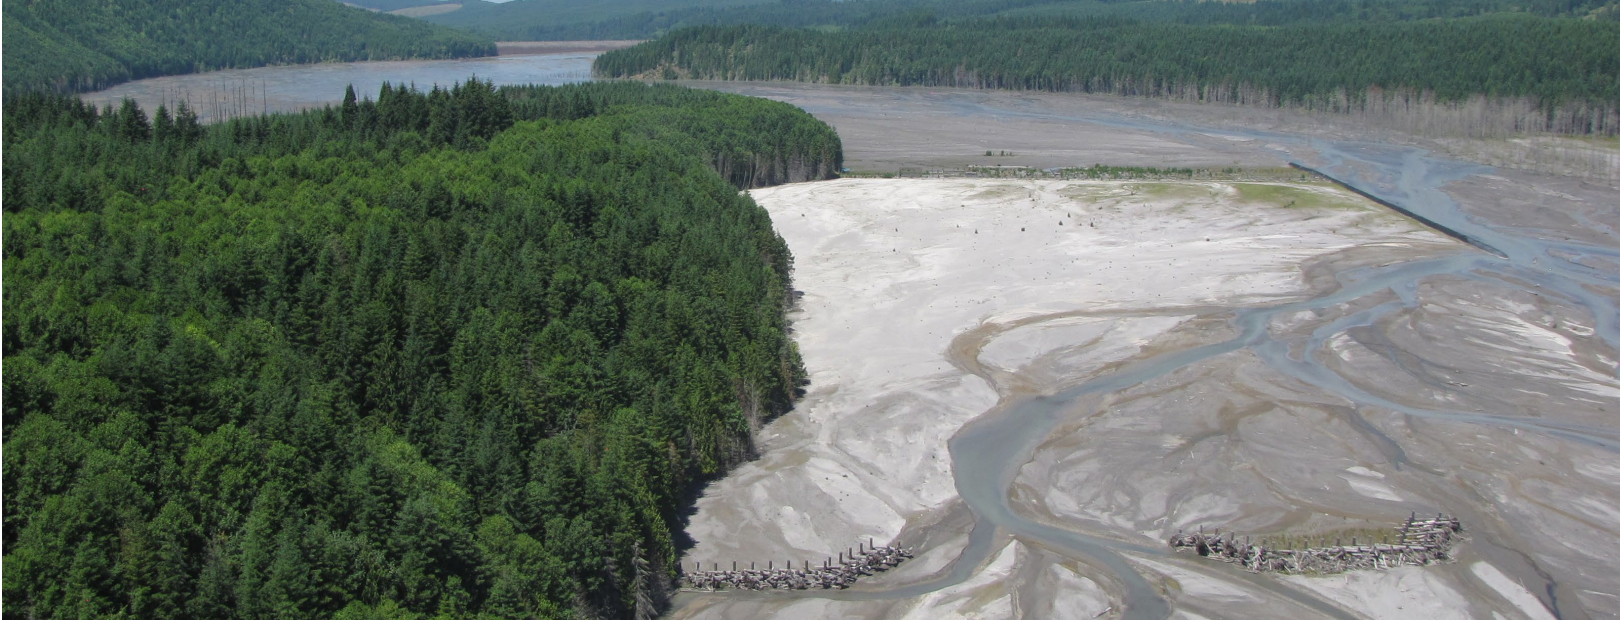
Cross Valley Structure. Note how large body of sand stored upstream of the **CVS** is excluding the NFTR and diverting around the **False-Valley Wall**.

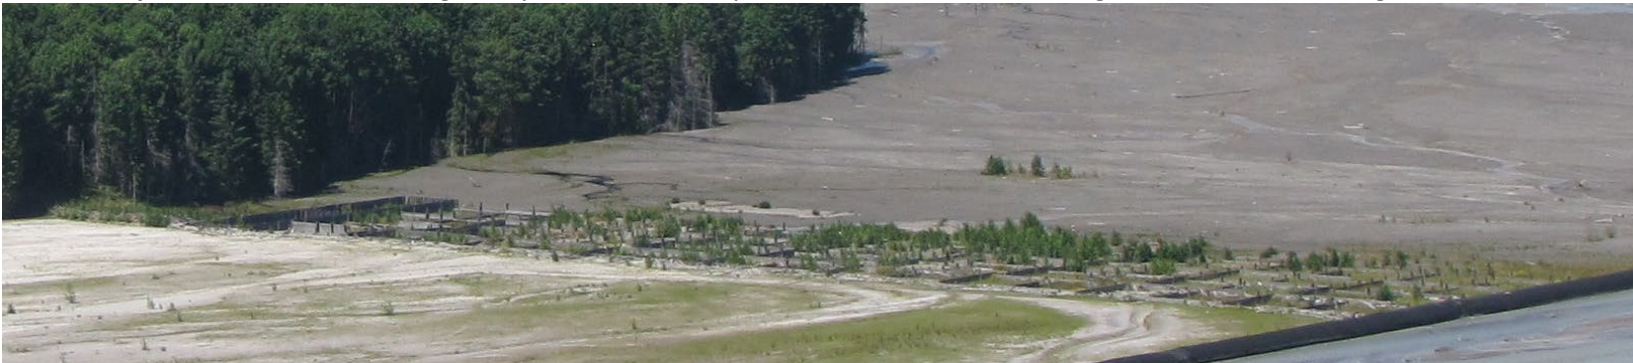
Cross-Valley Structure. Note extensive vegetation (including shrubs, trees and wetland species) now colonising the cells within the structure.

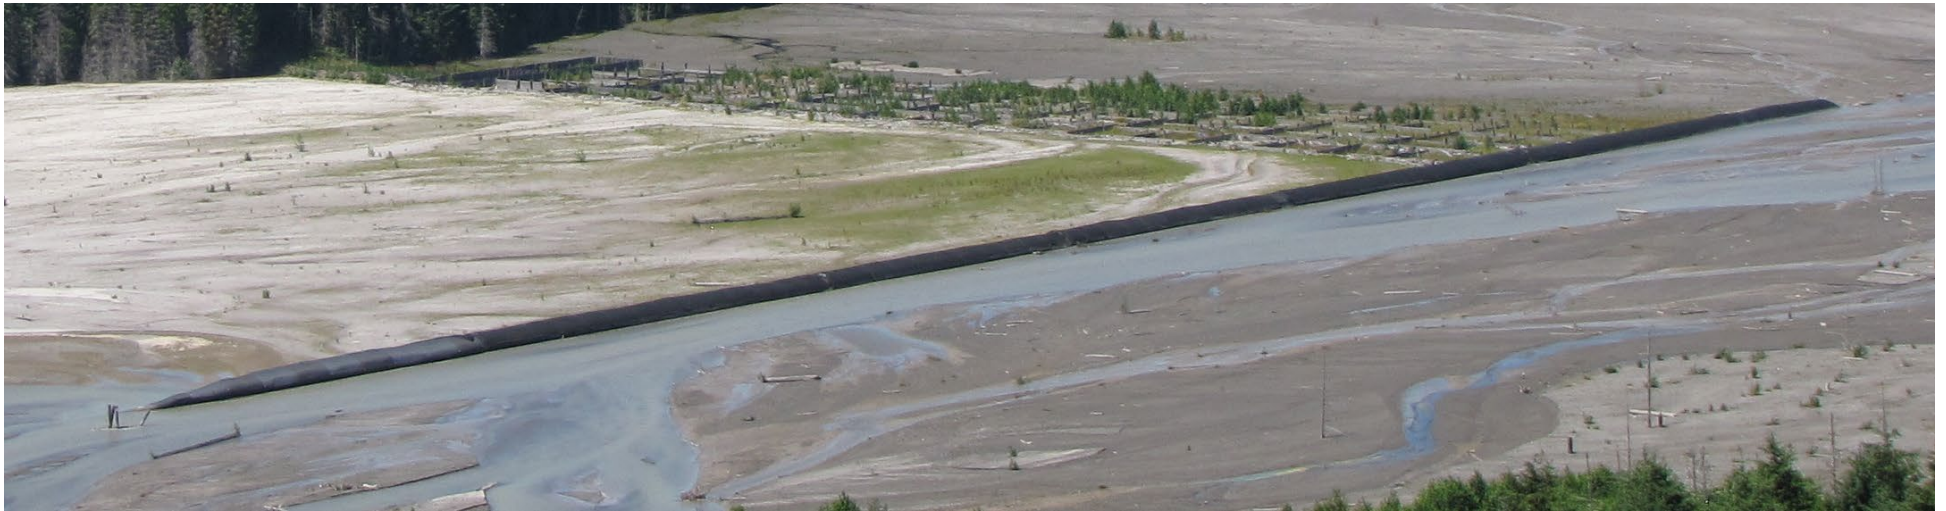
False-Valley Wall. Note generally good condition and continued effectiveness of geotube, but leaning of piles, sinking of tube and loss of protective fabric covering the geotextile at upstream, end due to local scour.

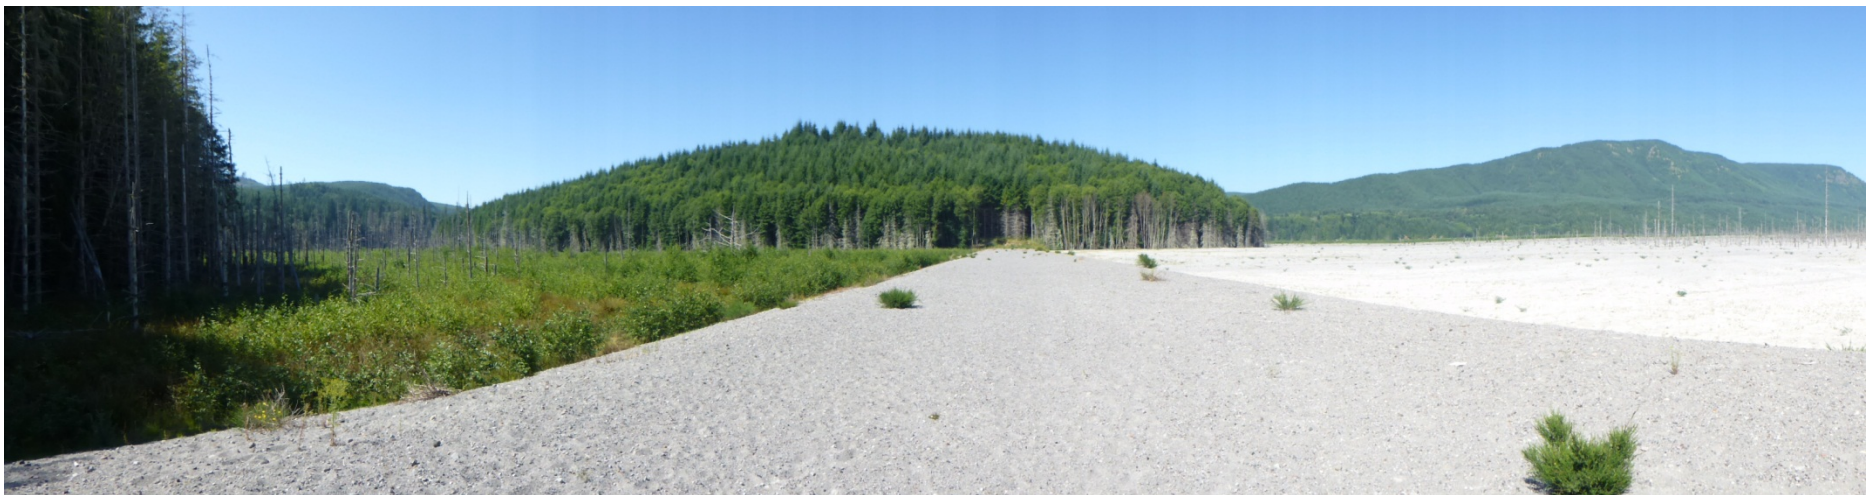
Diversion Berm. view along berm from southern end. Note elevation difference between sediment plain upstream and downstream of berm and low elevation of berm crest relative to sediment plain upstream.

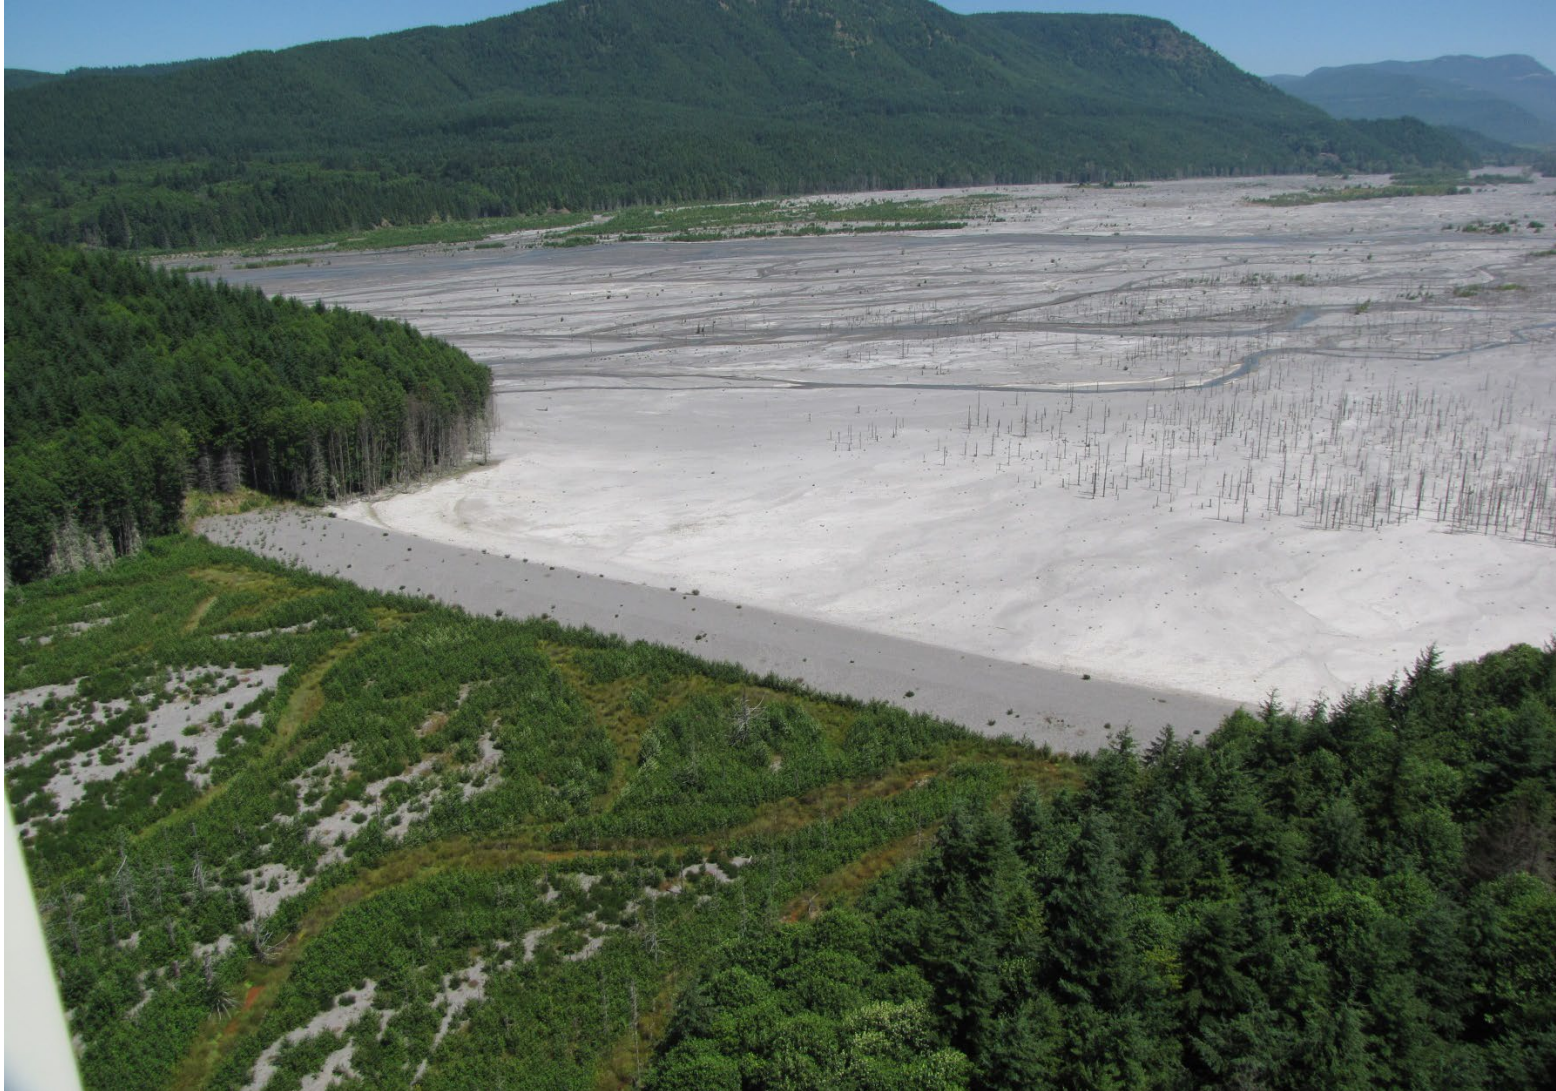
Diversion Berm. View upstream. Note extensive sand deposit upstream of berm that excludes NFTR, good condition of berm structure and extensive, vegetation downstream, with well developed channel network carrying exfiltrating, clear water flow that has probably seeped beneath the Diversion Berm.
